Intel[®] 82598 10 Gigabit Ethernet Controller Specification Update

November 2008

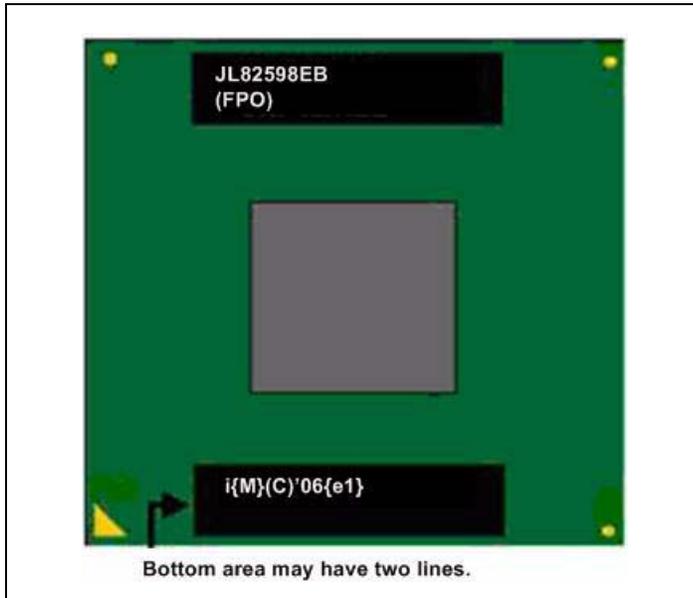
Figure 1-1. Example Showing 82598 Identifying Marks

Lead-free parts will have “JL” as the prefix for the product code (vs. “HL”) and that the “Q” designator refers to the Q Specification number in the table above.
